**Greens Reconstruction Project**  
**Weekly Report #10**  
**June 10, 2020**

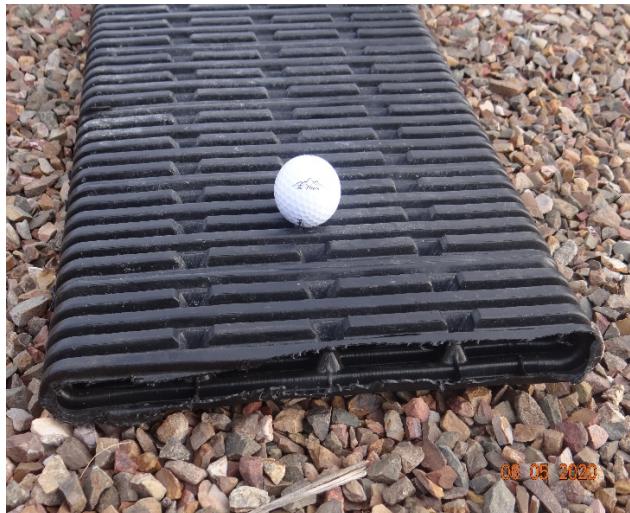
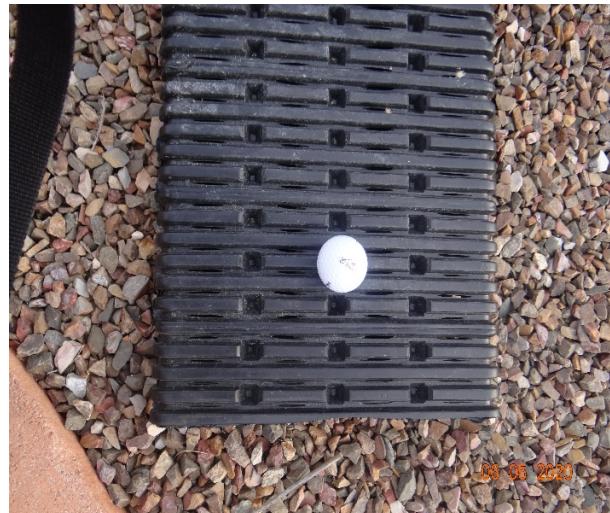
I have been asked questions about the flat drainpipe that is being installed under the greens. A sample of the "flat drainpipe" is available outside the proshop for viewing. For those not in residence, the following photos show the flat drainpipe. (Golf ball added for perspective) The photo on the right shows the small slits where excess water will pass into the flat drainpipe and ultimately flow away from the green. This will prevent the future buildup of salts from the reclaimed water used for irrigation.

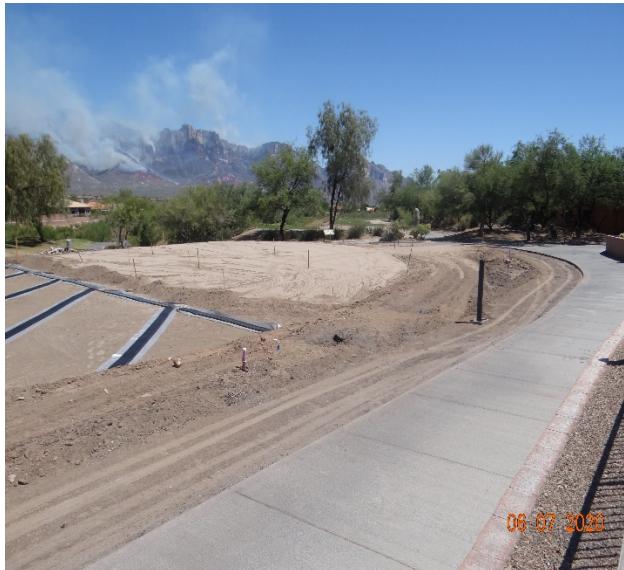
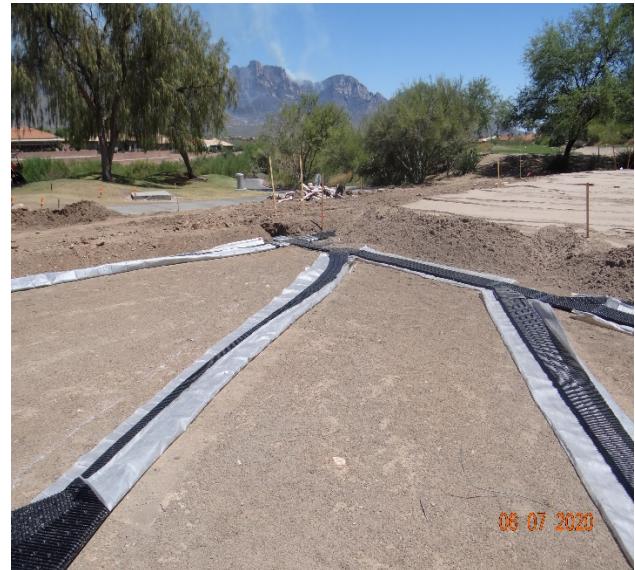
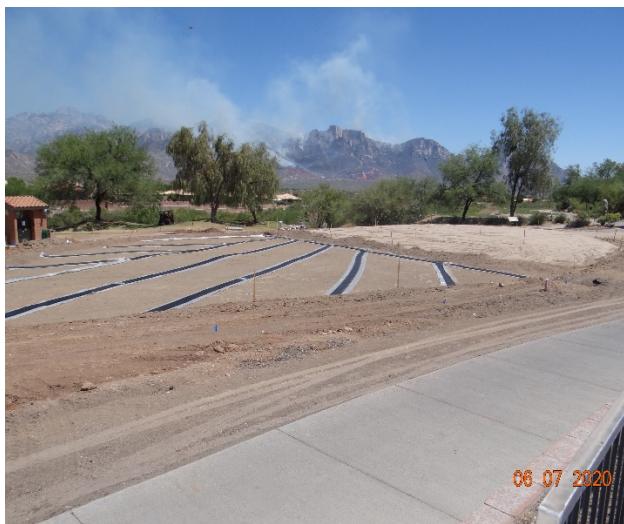
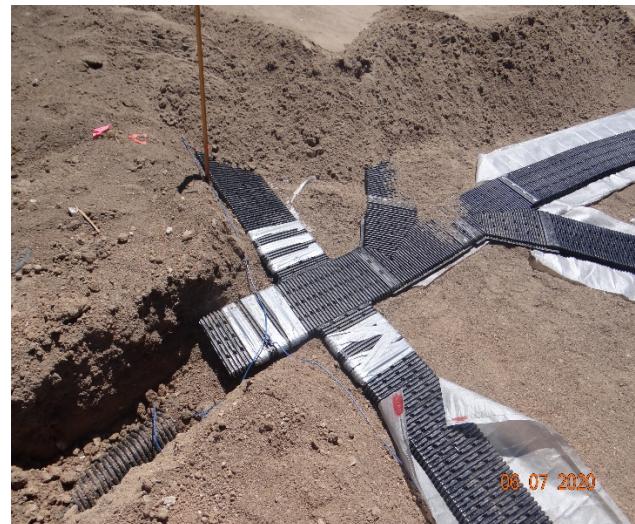
The following photos show the putting green with the flat drainpipe installed and the sand installation 50% complete. You can also see the smoke from the fire in the Catalina Mountains. (More later)

The photo on the bottom right shows where the flat drainpipe comes together at the outfall drain location, the low point of the green. "Fittings" are used at this point to join the flat drainpipe to the round outfall drainpipe away from the green.

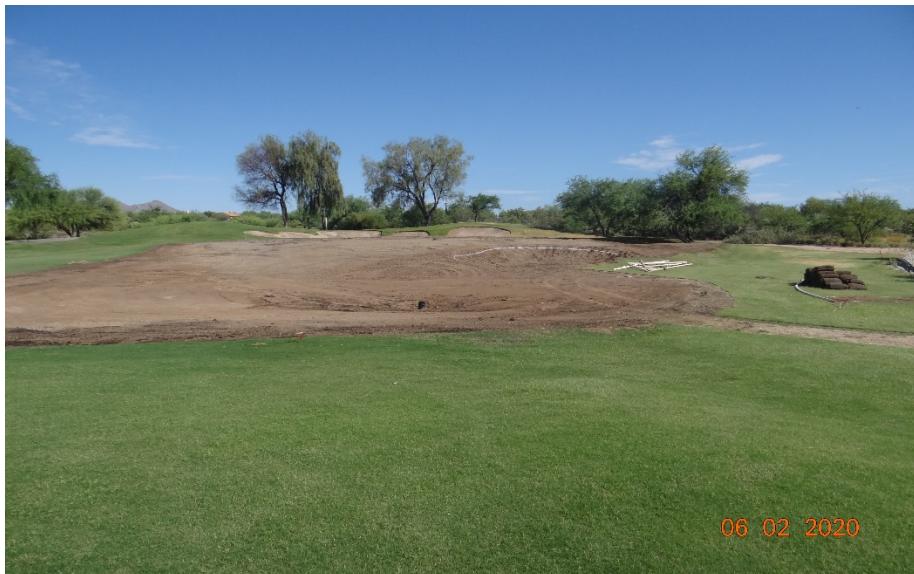
A couple of things to notice. A “fore” bunker (see white outline) has been added to #5. This bunker is 25 yards short of the green. However, when viewed from the fairway it appears to be in front of the green.

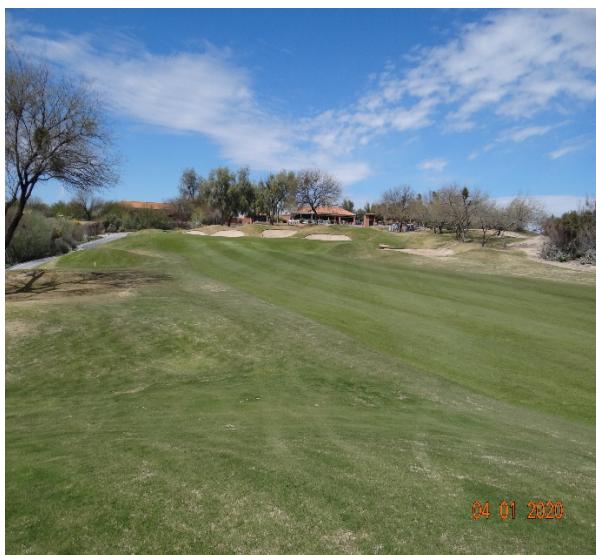
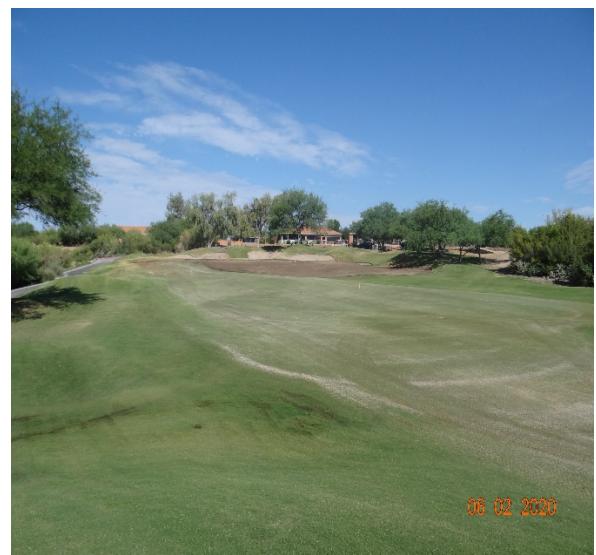
You will also notice that the #9 green has been moved 15' to the player's right, away from the short game practice area and the cart path. The right front sand trap on #9 has also been removed. Photos below are before and as of June 7<sup>th</sup>.

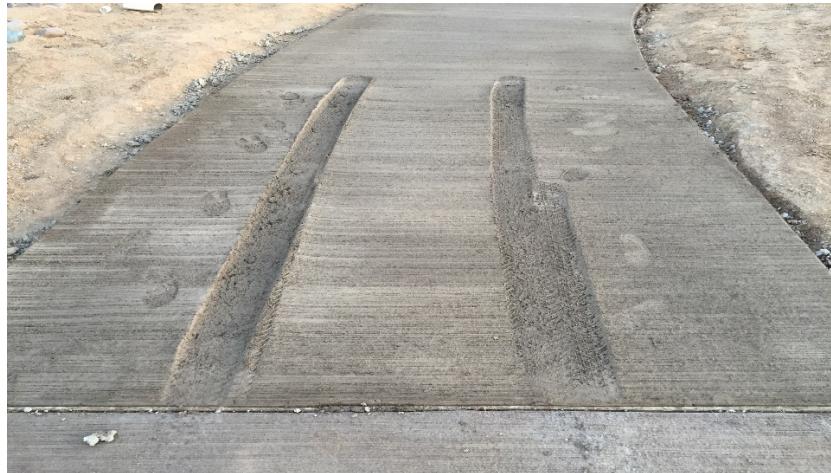
Work has begun on the concrete cart paths as of Monday June 8<sup>th</sup>, around the 1<sup>st</sup> and 10<sup>th</sup> tees, putting green, and driving range areas. This work will be completed the week of June 7<sup>th</sup>. These cart path areas will be closed to cart path traffic for 10 days after completion to allow the concrete to cure. Please respect the barriers! The contractor will remove the barriers after the ten (10) day cure time has passed. We do not want this to happen to us! (Actual photo from another project.)

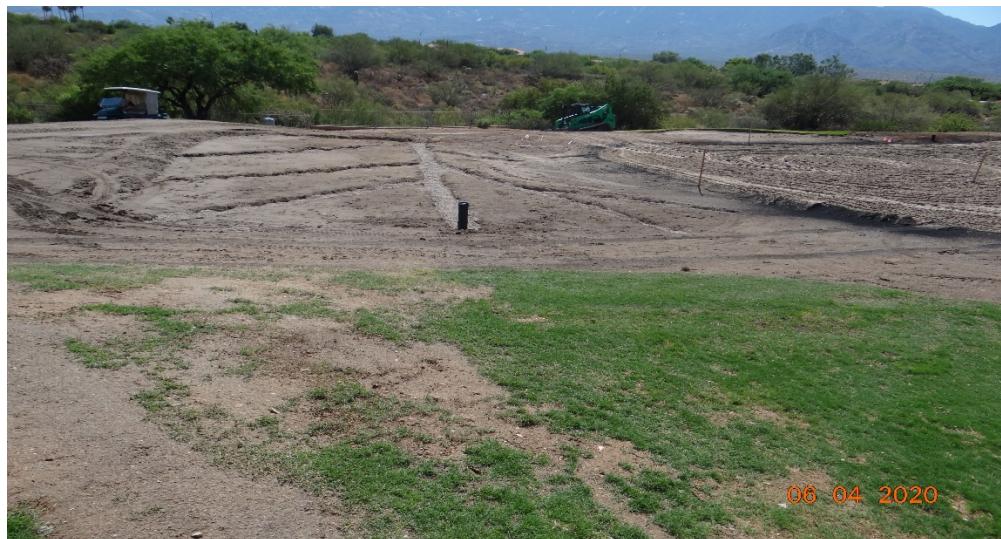
Additional drainage is being installed in areas that have traditionally been wet. It is hard to grow grass and is difficult for players in these areas. The following photo shows the additional drainage installed in front of #15.

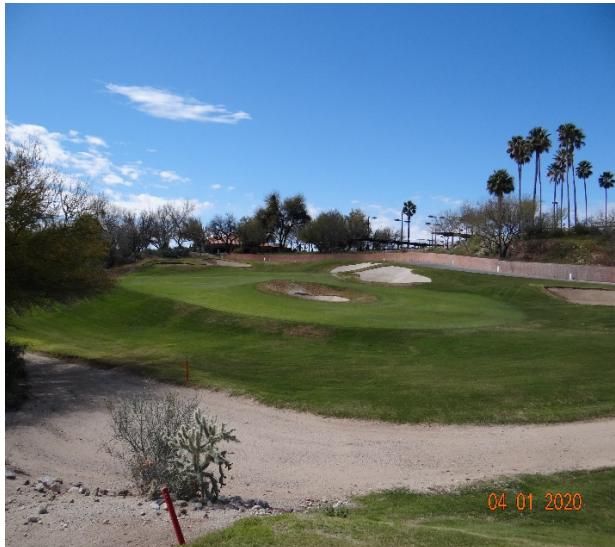
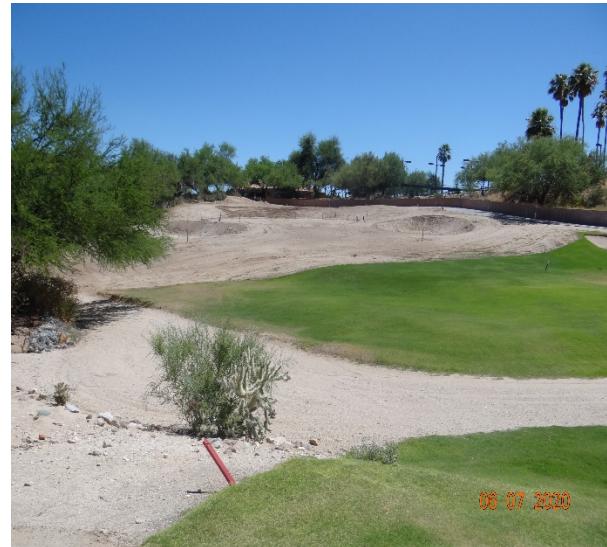
Below are before construction and current photos of #18. Left is before the project started. The right is June 7<sup>th</sup>. Note that the “Pot bunker in the front is gone and new bunkers are both right and left.

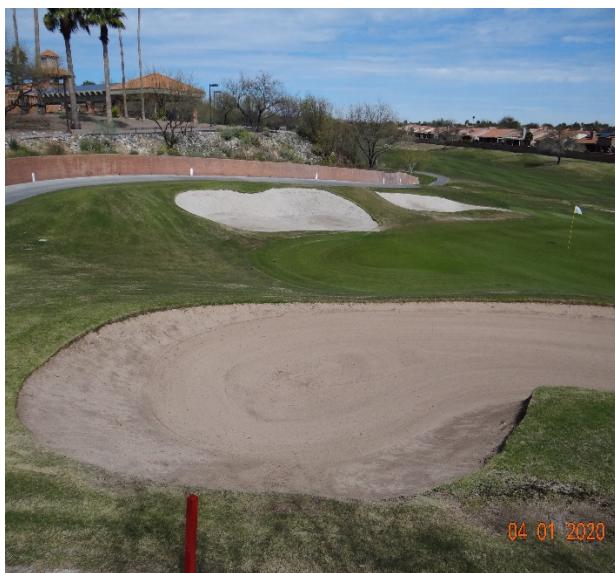
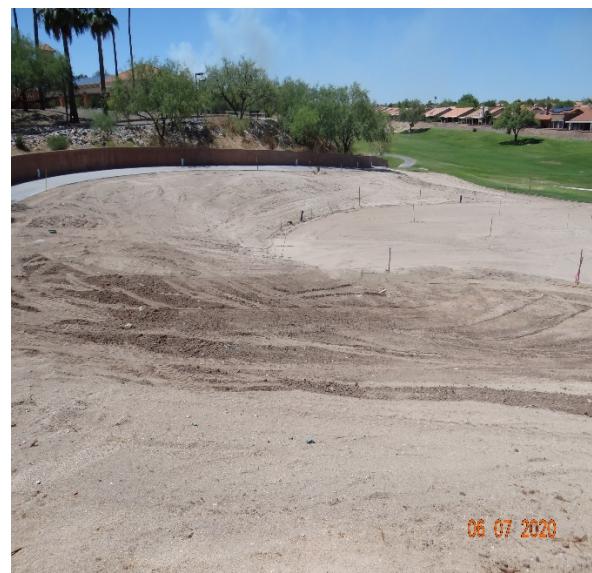
Photos taken from behind the green show the before, and current after the two bunkers on the player's right of the green and the bunker behind the green have been removed. The area has been sloped for improved and safe maintenance, and to channel surface water away from the green.

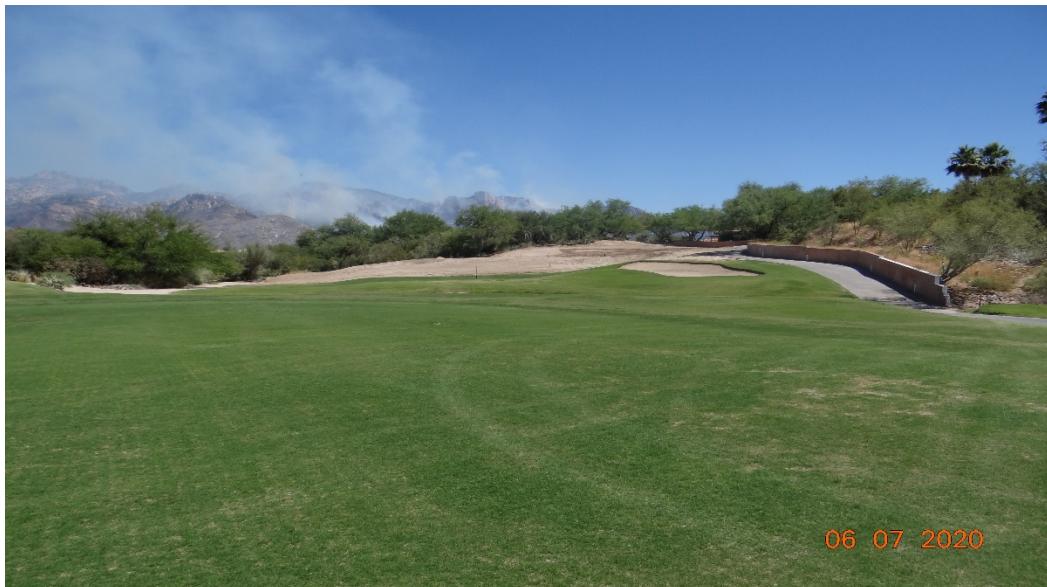
This photo shows #18 on June 7<sup>th</sup> as viewed from the 100-yard marker in the fairway.
