**Greens Reconstruction Project**  
**Weekly Report #13**  
**July 1, 2020**

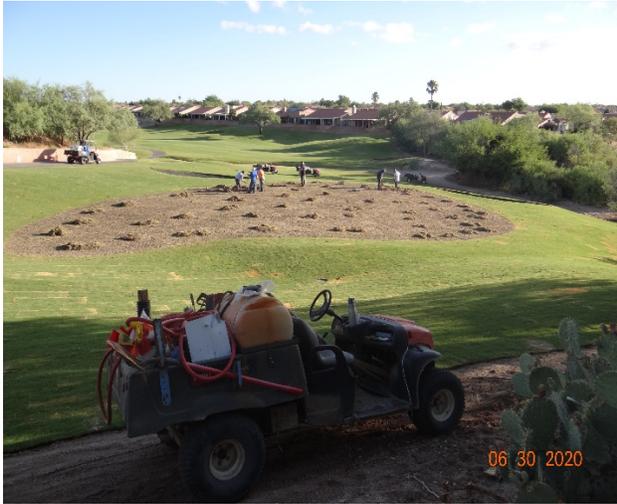
It was observed early the week of June 29<sup>th</sup> that the greens were collapsing. Investigation into the problem determined that greens mix sand was being carried away from the greens through the drainage system. This resulted in a sinking of the greens surface above the flat drains.

#18 – Sprigs Raked Up

The process of correcting this problem is to: 1) to remove the sprigs on the back nine greens; 2) excavate and expose the flat drain pipe in all of the greens; 3) flush the flat drain pipes; 4) install fabric over the flat drain pipes; 5) replace the greens mix sand; 6) reestablish the contours on the greens; and 7) re-sprig the back nine greens.

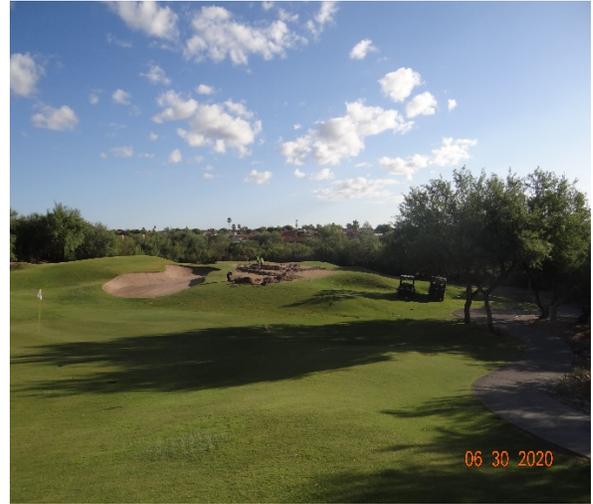
Changes to the flat drainage pipe and the fabric negated the previous concerns. However, we were not made aware of these changes. The result was that the greens mix sand did not form a bridge, sand migrated into the flat drains, and the greens began to collapse.

#17 – Exposing Flat Drains
